Cultural Heritage Monuments in Myanmar Hit by Cyclone Nargis

Cyclone Nargis was a powerful tropical cyclone that caused the most devastating natural disaster in the recorded history of Myanmar. The cyclone slammed the southern part of the country in May 2008, leaving massive destruction in its trail and an estimated 146,000 deaths, 2.4 million people destitute, with several thousands more missing. There are fears that about a million people might have perished or would die from the calamity, and damage was estimated at more than US\$10 billion. Nyunt Han, former Director-General of Myanmar Department of Archaeology, visited the areas affected by the cyclone a month after the tragic event, and reports on a preliminary and limited survey that he carried out on the damage caused to historic monuments as a result of the catastrophe.

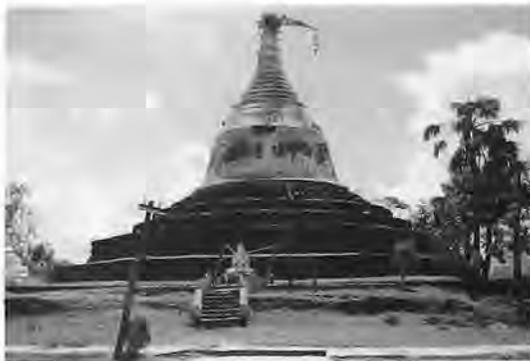
Figure 3: The umbrella of Maung-ti pagoda was broken, and ancient plasters on the bell-shaped dome were torn off. Maung-ti pagoda was built in lower Myanmar by King Anawrahtar of the Bagan kingdom in the 11th century AD. It was of a peculiar architecture featuring a Bagan-type pagoda built on five receding terraces made of laterite stone blocks. (photo by Nyunt Han).

Damage was also caused to the umbrellas or chattravali of many ancient pagodas, namely Maung-ti pagoda in Twantay [Figure 3]; Kyaik-khauk pagoda in Thanhlyin; Kyaik-kasan pagoda in Thingangyun; and many small stupas (ayan cetis) surrounding the Shwe Dagon pagoda in Bahan [Figure 4].

Another historically significant pagoda damaged was Maung-ti pagoda in Twantay, lower Myanmar. It was a Bagan-type pagoda built by King Anawrahtar of the Bagan kingdom in the 11th century AD. Many large terracotta votive tablets (45 cm in height x 30 cm in breadth) [Figure 17], bearing Bagan-type Buddha images, were found near Maung-ti pagoda during excavation, and are now kept in a shed nearby. The force of the cyclone tore off ancient plasters covering the bell-shaped dome of the stupa (see Figure 3).

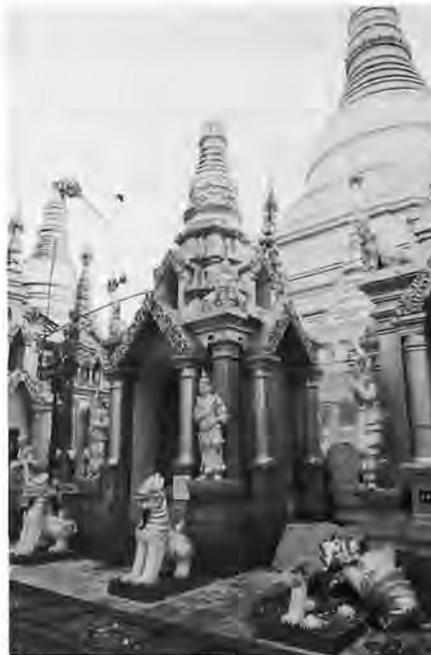
Figure 4: The toppled umbrellas and top pinnacles of many "ayan-pagodas" (surrounding stupas). These pinnacles add to the magnificent view of the Shwe Dagon Pagoda in Bahan. (photo courtesy of the Shwe Dagon Pagoda Trustee Committee).

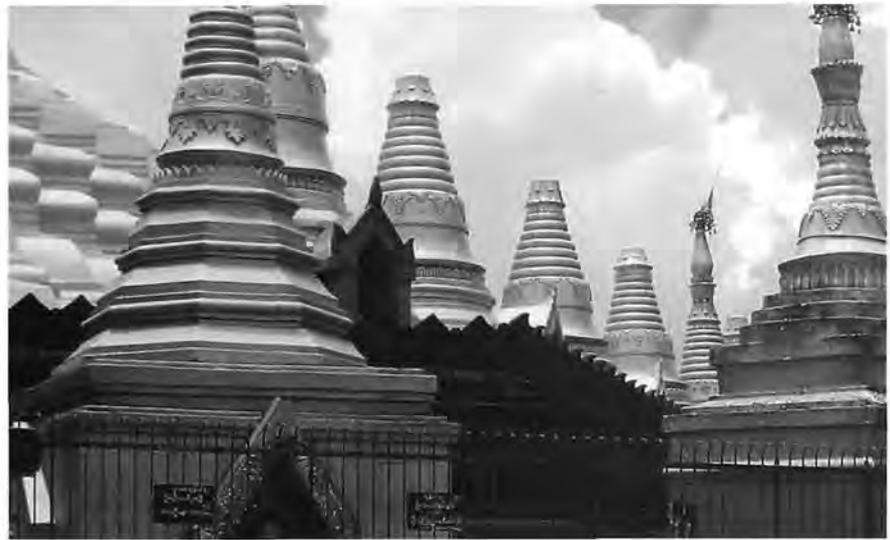
Figure 6: The Shwe Santaw Pagoda in Twantay, within which the hair relic of Buddha was enshrined, was built in the 11th century AD. The umbrellas and pinnacles of small stupas crashed into pieces (photo courtesy of the Pagoda Trustee Committee).

The pinnacles of stupas of the Kyaik-khauk pagoda [Figure 5]; Shwe Santaw pagoda in Twantay [Figure 6] and Shwe Dagon pagoda in Bahan were toppled as a consequence of the disaster. Many multiple roofs on top of pavilions such as those at Kyaik Hmaw Wun pagoda [Figure 7] and Shwe Dagon pagoda [Figure 8] collapsed. The multi-tier roofs and decorative wood carvings, which add to the grandeur of

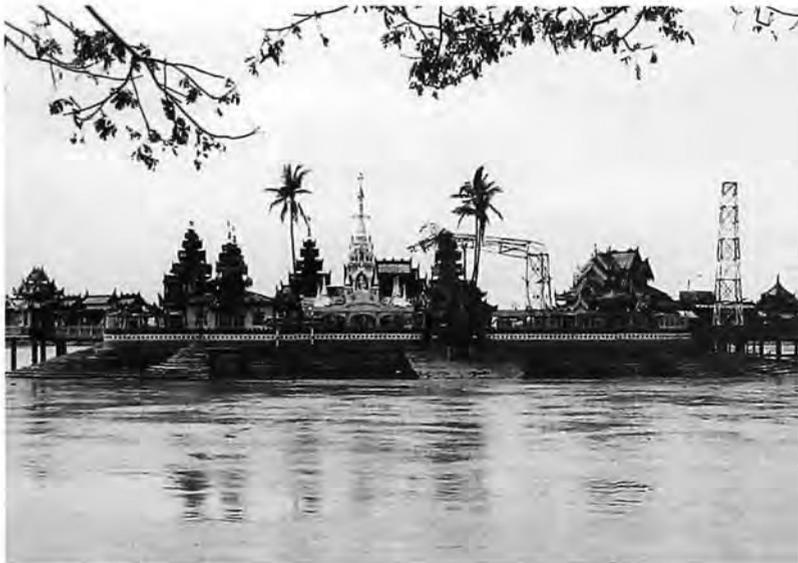
Figure 7: Kyaik Hmaw Wun Pagoda built on a rocky island in Kyaik-tan, is accessible only by boat, and the pagoda was crowded with pilgrims and visitors every day. The "prasat" (pavilions) on the platform of Kyaik Hmaw Wun Pagoda were also damaged by the cyclone (photos courtesy of the Pagoda Trustee Committee).

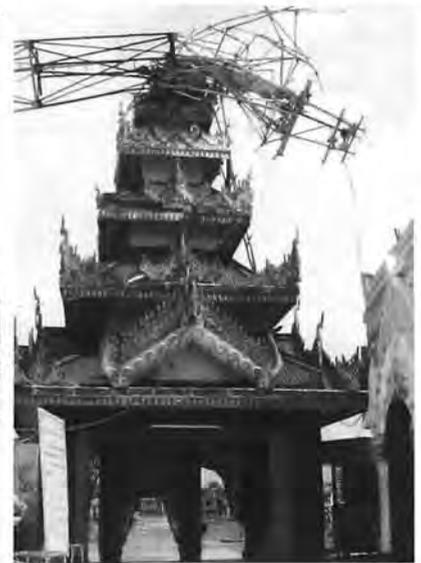
Figure 8: The pinnacles of small surrounding stupas which add to the grandeur of the Shwe Dagon pagoda were in ruins (photo courtesy of the Shwe Dagon Pagoda Trustee Committee).

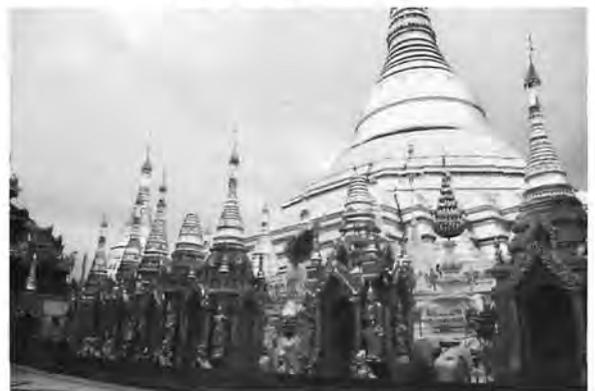
Figure 9(a): Damaged pavilion at Kyaik Hmaw Wun pagoda.

Decorative carvings on the pavilions of many pagodas, some depicting the "Jataka" (stories of Buddha's life), and others with carvings of traditional floral designs of 15th-18th centuries AD, fell and broke into pieces (photo courtesy of the Pagoda Trustee Committee).

the shrine halls in Kyaik Hmaw Wun pagoda [Figure 9 (a)], Kyaik-khauk pagoda [Figure 9 (b)], and Shwe Dagon pagoda [Figure 10] were damaged and scattered on the platform.

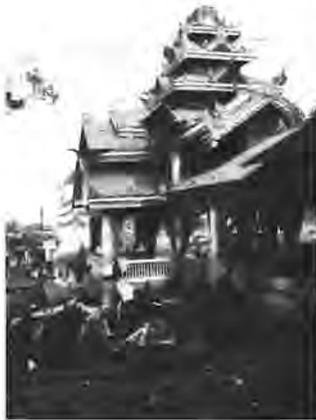
Figure 9(b): The view of a damaged entrance pavilion at Kyaik-khauk pagoda (photo courtesy of the Pagoda Trustee Committee).

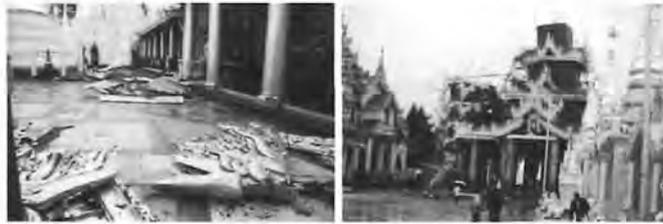
Figure 10: Beautiful wooden carvings which decorated the shrine halls lie broken on the platform of the Shwe Dagon Pagoda (photo courtesy of the Shwe Dagon Pagoda Trustee Committee).

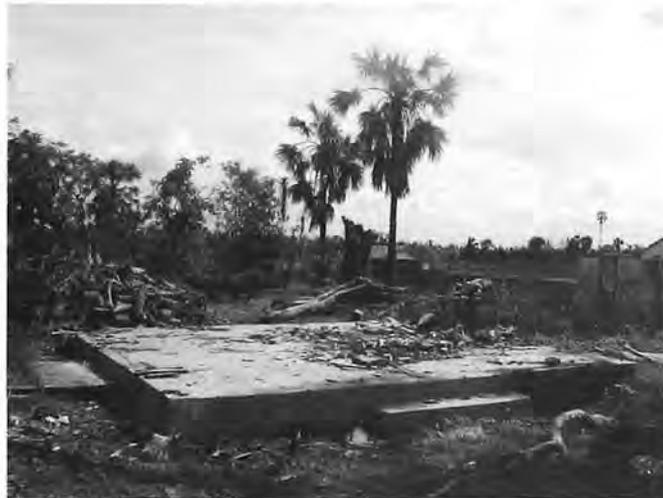
Figure 11: The scene of a wooden shrine totally blown away from the brick platform near Maung-ti pagoda in Twantay (photo by Nyunt Han).

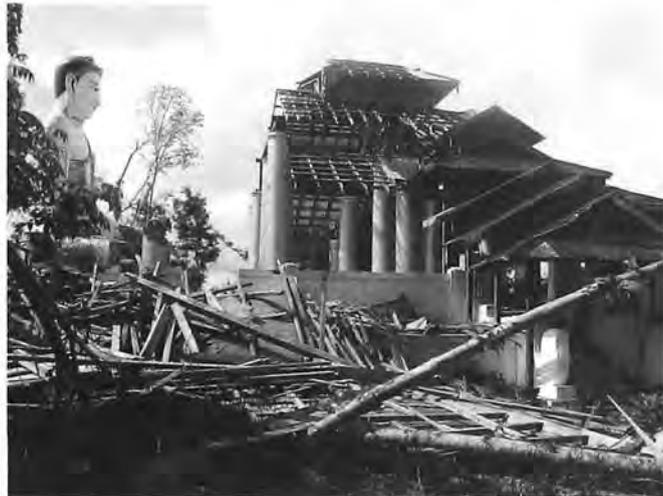
Figure 12: A large Buddha image shrine hall at Aung Zay Yone pagoda, in Kyauk-tan, which was severely damaged (photo by Nyunt Han).

Similarly, shrine halls such as the one in Maung-ti pagoda [Figure 12] and Aung Zay Yone pagoda in Kyauk-tan [Figure 13] were extensively damaged, and now stand as tragically sorrowful sights.

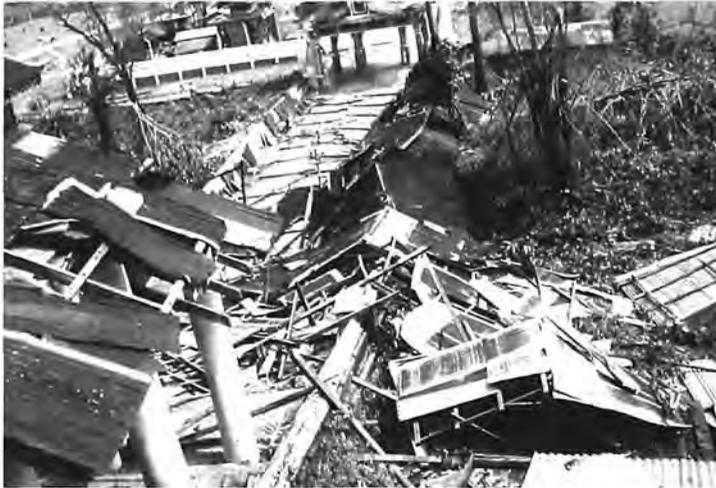
Figure 13: At Kyaik-khauk pagoda in Than-hlyin, the roof-covered stairway on the northern side collapsed to the ground. Many roofs of corrugated sheets were ripped off (photo courtesy of the Pagoda Trustee Committee).

The complete collapse of the northern roof-covered stairway at the Kyaik-khauk pagoda in Than-hlyin [Figure 11] illustrates the extent of the destruction. The pagoda was built in the 15th century AD as evidenced by 15th-century AD bronze Buddha images found inside the relic chamber of the pagoda. At the site are Buddha image shrine halls decorated with wooden carvings on the platform of the pagoda. As the monument was built on a

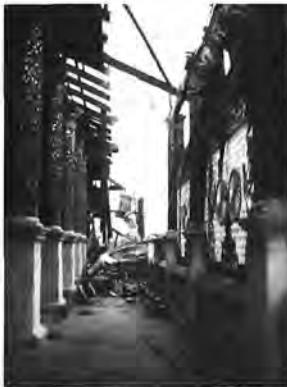
Figure 14(a): The roofs of Ngar-htat-gyi pagoda (photo courtesy of the Pagoda Trustee Committee).

The roofs of the main shrine hall of the following monuments were ripped off by the Nargis cyclone: the Ngar-htat-gyi pagoda [Figure 14 (a)], Chauk-htat-gyi pagoda [Figure 14 (b)] and Taing-tayar old monastery [Figure 14 (c)].

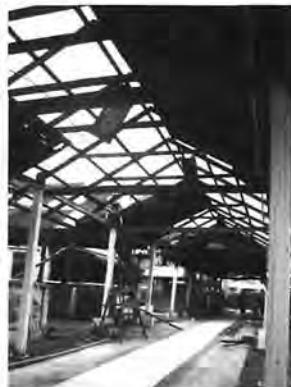
Figure 14(b): The roofs of Chauk-htat-gyi pagoda (photo courtesy of the Pagoda Trustee Committee).

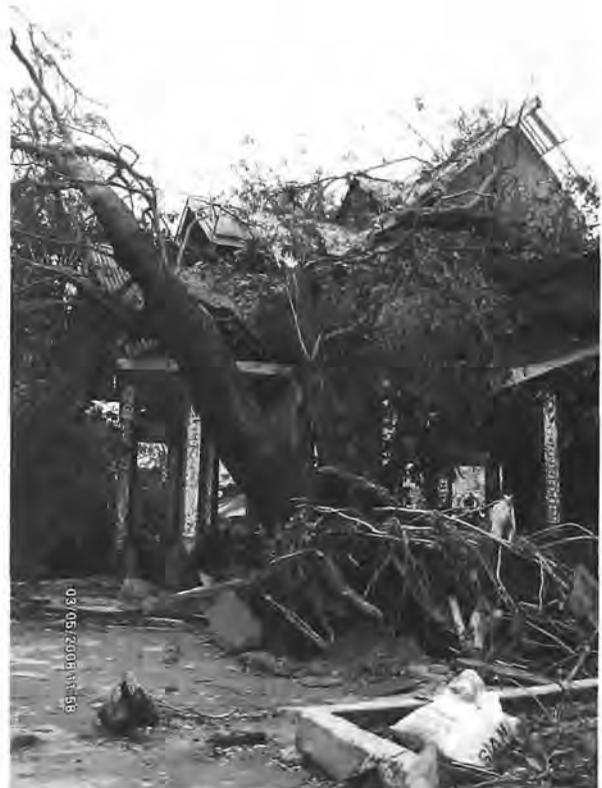
Figure 14(c): The roofs of the old Taing tayar wooden monastery of about 150 years old were blown away by the cyclone (photo courtesy of the Pagoda Trustee Committee).

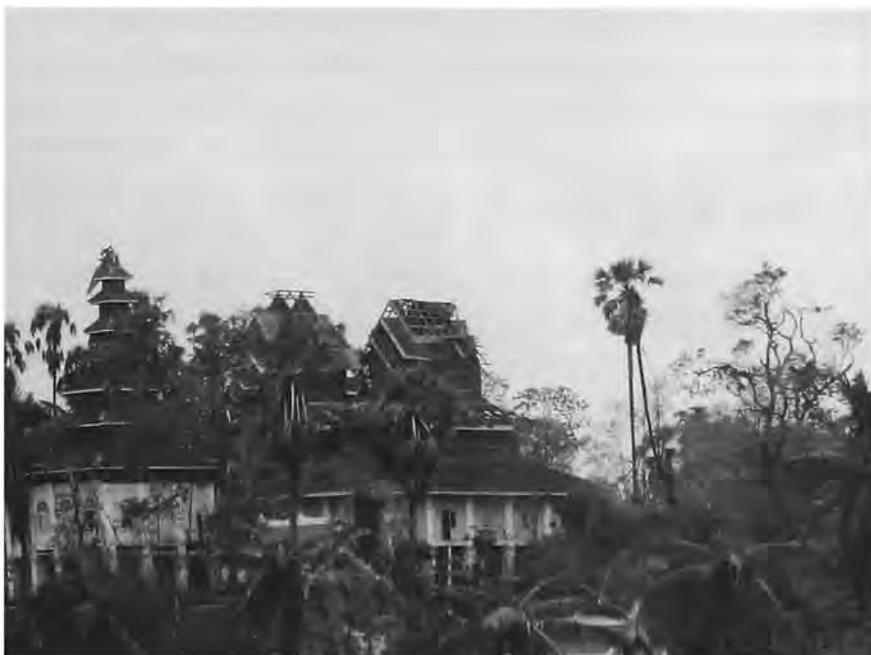
Figure 15(b): A ruined shrine hall at the Melamu pagoda in North Okkalapa (photo courtesy of the Pagoda Trustee Committee).

At the Kyaik-ka-san pagoda [Figure 15 (a)] in Thin gangyun as well as the Melamu pagoda in North Okkalapa [Figure 15 (b)], huge trees fell onto nearby shrine halls, causing grave damage.

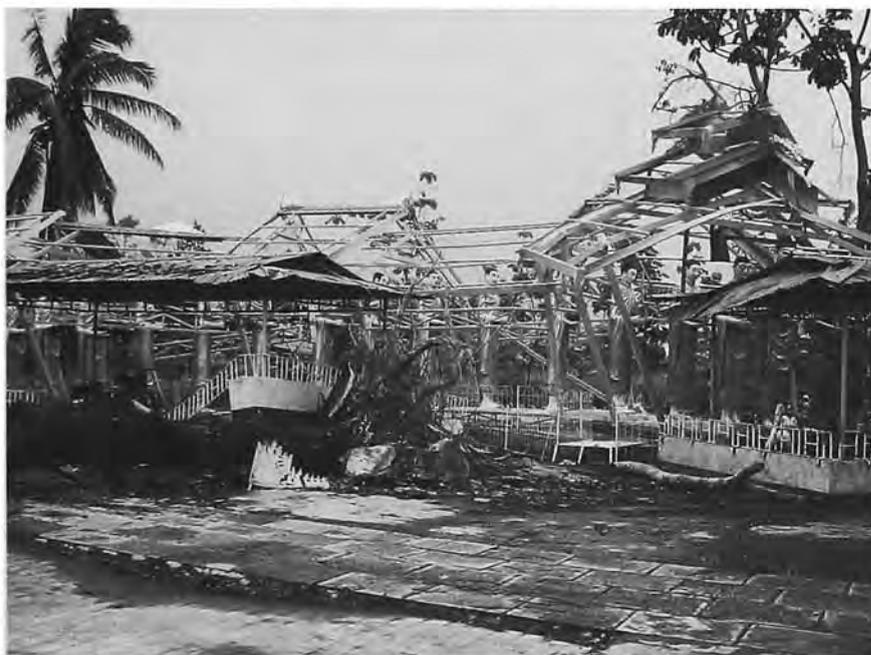
Figure 16: The ancient kilns in Twantay which produced glazed ceramics are dated to the 15th century AD. After archaeological excavations, the Department of Archaeology built wooden sheds to house these ancient kilns. These wooden sheds, together with the brick walls of the ancient kilns, had collapsed (photo by Nyunt Han).

Apart from the pagodas and shrines, ancient kilns which were excavated in 1998 by the Department of Archaeology were also severely ruined [Figure 16].

The Shwe San Taw pagoda, a significant pagoda in Twantay, was also built by King Anawrahtar in the 11th century AD. It is believed that the Buddha's hair relic was enshrined in this pagoda. Ancient kilns in Twantay were not spared from destruction. Those in Phayagyi village and near the Kangyigon village were glazed pottery kilns of the 15th century AD. The Department of Archaeology excavated the sites in 1998, and the exposed kilns were housed under wooden sheds. The cyclone fell all the wooden sheds along with the brick walls of the ancient kilns.

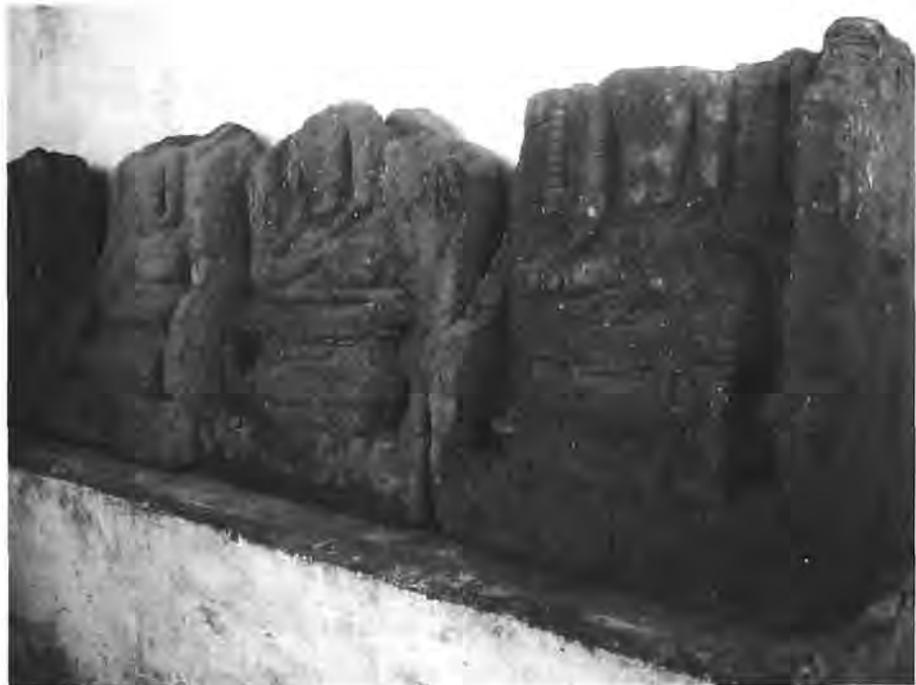
Figure 17: Large terracotta votive tablets (measuring 45cm in height by 30 cm in breath), bearing Bagan-type Buddha images, were found during excavation. Since these votive tablets are important archaeological objects of the Bagan period, they are kept in a shed near Maung-ti pagoda (photo by Nyunt Han).
